FALLS CREEK, PA.  
N4107.5—W7845.7.5  
1966

# LANDSLIDES AND RELATED FEATURES OF THE FALLS CREEK, PA QUADRANGLE

by  
John S. Pomeroy  
1981

U.S. Geological Survey  
OPEN FILE MAP 81-238 (B-10)

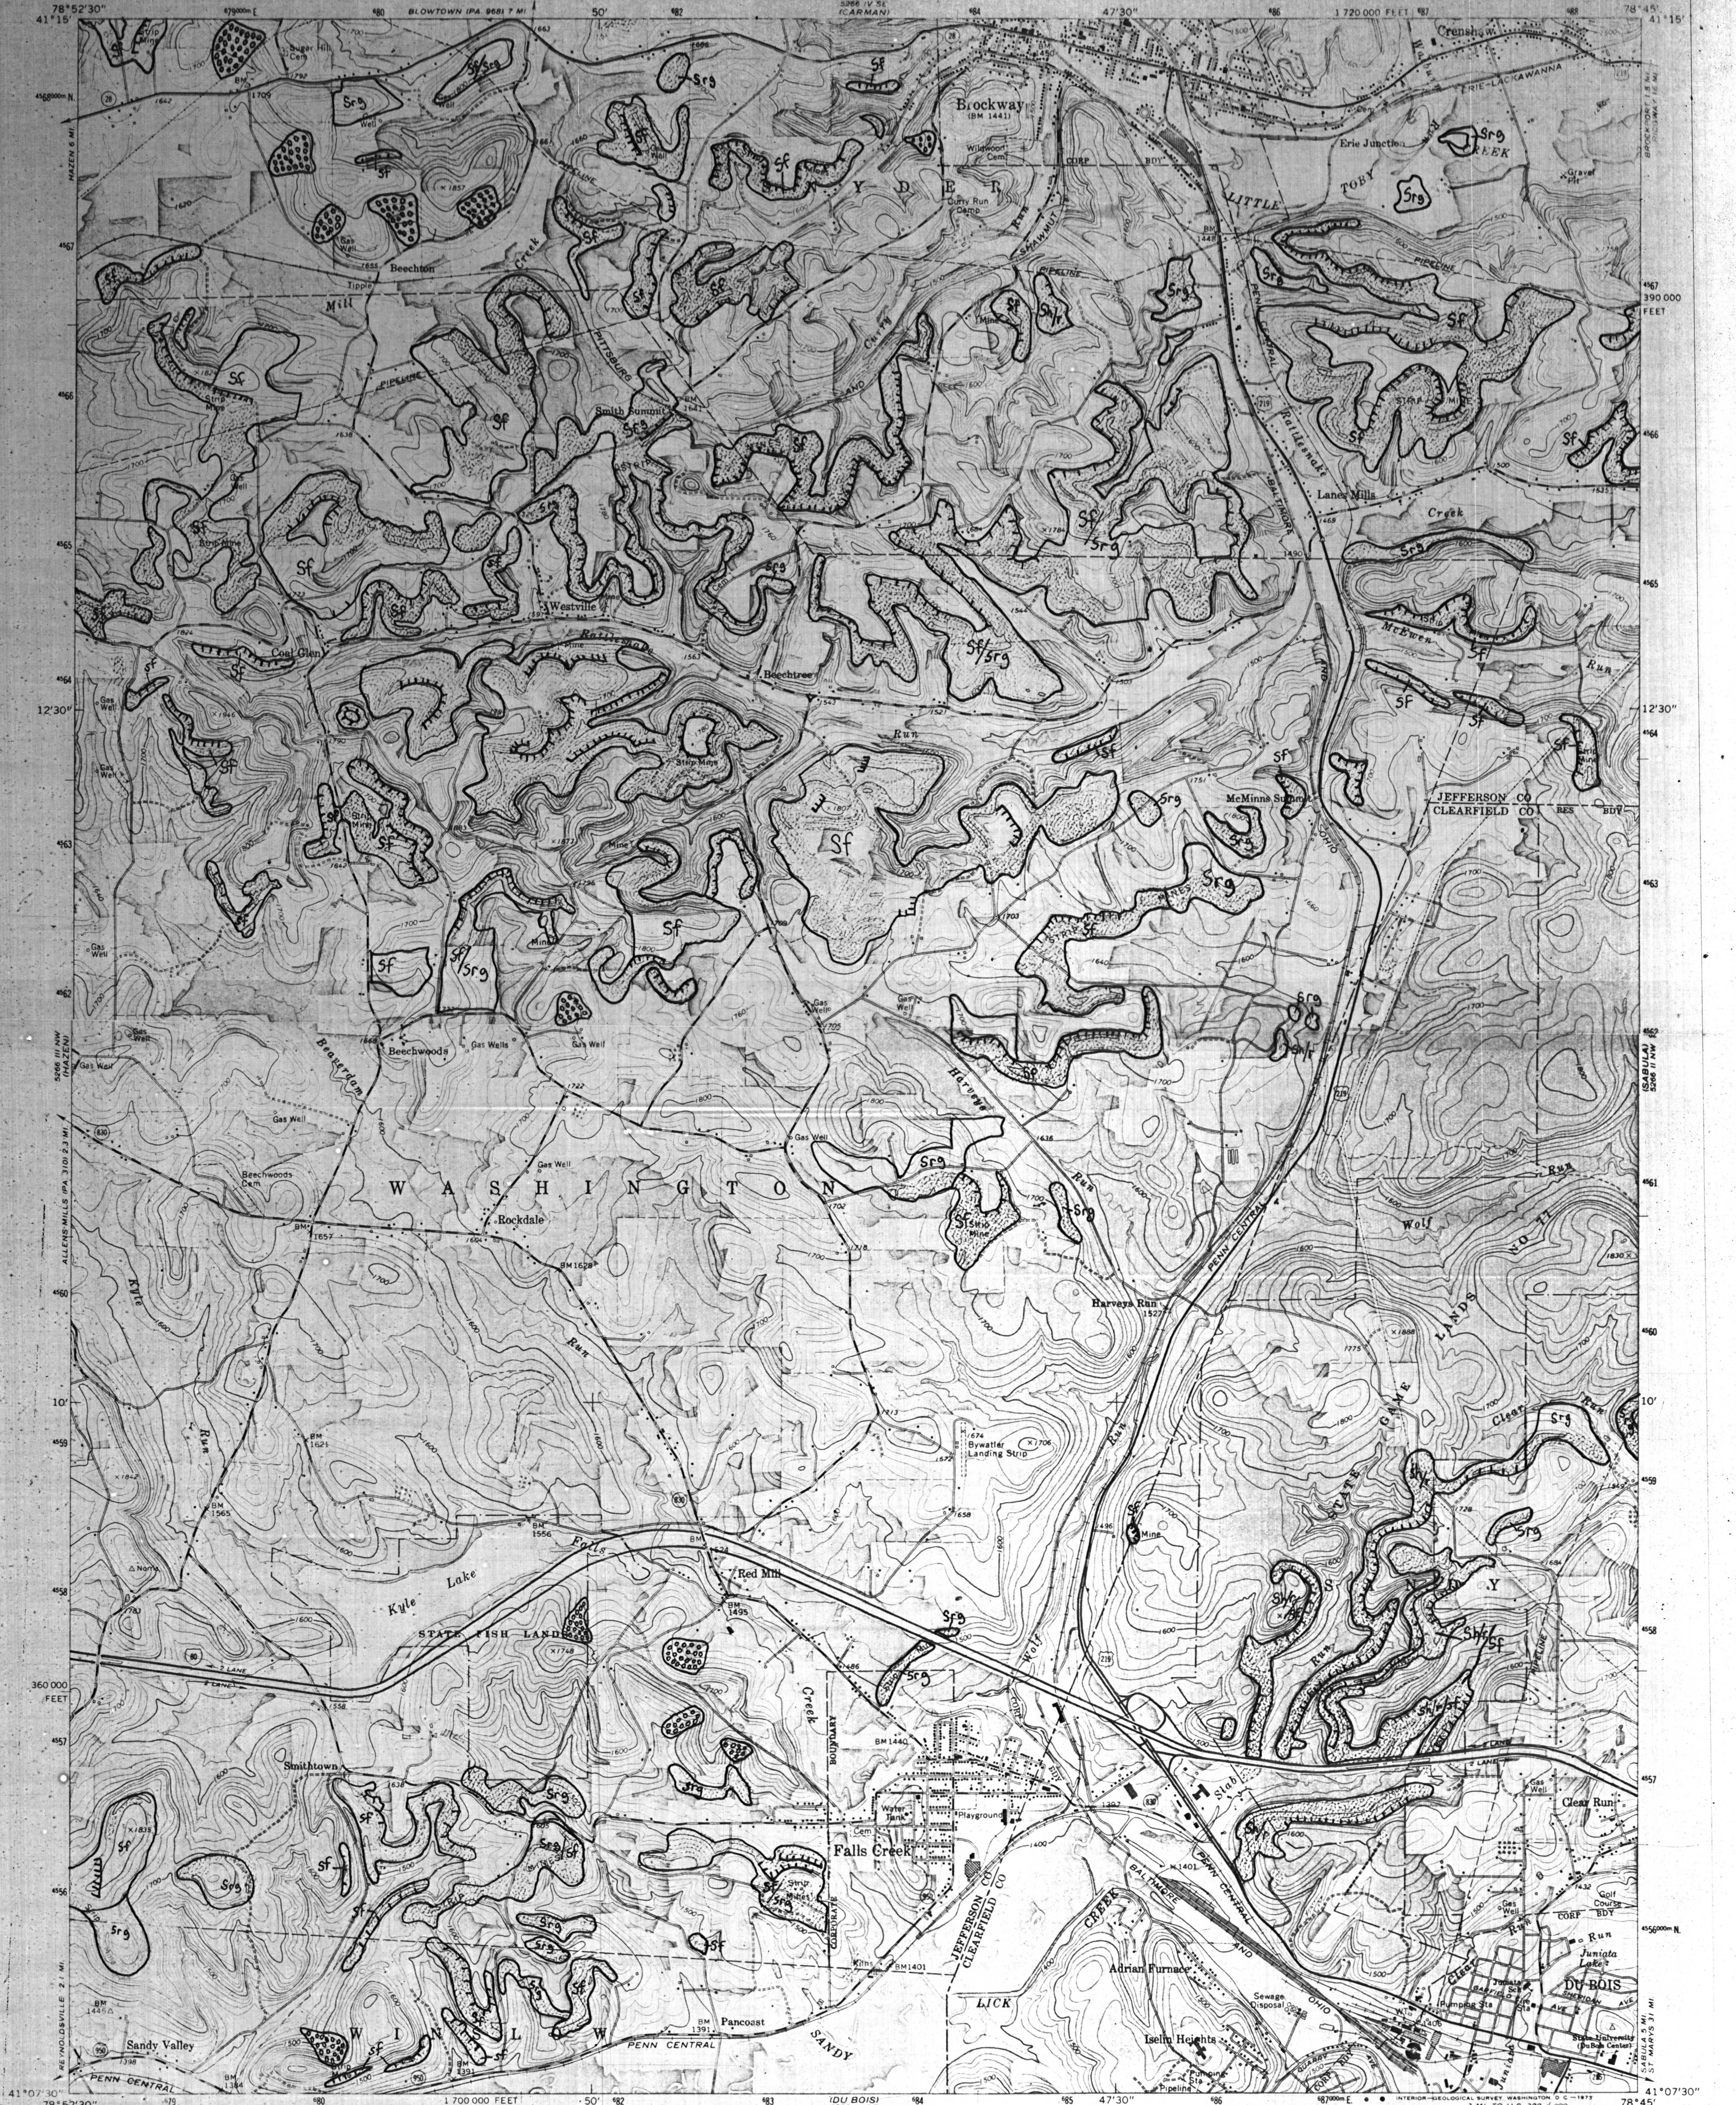
**MAN-MADE FEATURES**  
Strip mines (combination of letter symbols  
indicates complex formed of more than one  
type of strip mine)  
sh bench with high wall  
sf furrowed with high wall  
sd multiple furrows and multiple benches  
ss hilltop removed  
srg reclaimed by grading  
sru reclaimed by secondary use  
sh/r reggraded in part, high wall  
remains  
Coal refuse banks  
r identified on aerial photographs;  
not classified in field check  
rb not burnt nor on fire  
rbb burnt  
rbd burning  
rbs sludge  
Quarries  
q quarry site  
qub spoil bank, quarry waste  
Gravel pits  
g site of gravel pit  
Slides in man-made features  
af earth flow in fill  
a/s earth flow in strip castings  
a/r earth flow in coal refuse

**ACTIVE OR RECENTLY ACTIVE LANDSLIDE**  
Complex landslide composed of earthflow, debris  
slide, earth and rock slump. Identified from  
historical records, and from scars, debris and  
other field evidence. Ground extremely unstable;  
sliding accelerated by excavation, loading and  
changes in drainage conditions. May include  
areas with several active slides too small to  
be shown separately. Questioned where doubtful.  
May be shown with symbol (A) where difficult to discern.

**OLD LANDSLIDE**  
Area of extensive hummocky ground caused by  
earthflow and earth and rock slump. Lacks  
clear evidence of active sliding. Relatively  
stable in natural, undisturbed state,  
generally not affected by small structures properly  
sited in areas away from the edge of the toe;  
can be reactivated by extensive, rapid exca-  
vation, loading, and changes in ground water and  
surface water conditions. Area of old landslide  
probably includes recent ones not identified  
from field evidence or otherwise documented.  
Upslope boundary of landslide generally defined  
by modified scarp, but downslope (toe) may be  
gradational and not well defined. Questioned  
where doubtful.

**COLLUVIAL SLOPE**  
Valley wall along major streams with slope as  
steep as 40° (85%); stony, clayey silt soil up  
to 50 ft. (15 m) thick; commonly buttressed by  
a terrace or bench at the toe of the slope; very  
susceptible to sliding by cutting of toe area,  
removal of terrace or bench, and overloading;  
slide commonly activated without apparent cause.

**AREAS SUSCEPTIBLE TO DEBRIS FLOWS AND DEBRIS  
AVALANCHES**  
Primarily shallow, narrow ravines and chutes with  
accumulation of stony colluvium generally 10 ft.  
(3 m) or less in thickness; susceptible to rapid  
movement during intense rainfall. Most ravines  
and chutes designated show evidence of former  
debris flows and avalanches. Symbol A design-  
ates historical debris flow or debris avalanche.

**AREAS SUSCEPTIBLE TO ROCKFALL**  
Steep, locally vertical, natural and man-made  
slopes and cliffs, 15 ft. (4.5 m) or more high;  
formed dominantly of sandstone, limestone, sandy  
shale, mudstone and claystone. Interbedded mud-  
stone, claystone and shale weather rapidly leaving  
sandstone and limestone rock faces unsupported.

**SOIL AND ROCK SUSCEPTIBLE TO LANDSLIDING**  
Soil and rock similar to that involved in land-  
slides elsewhere in map area; primarily areas  
underlain by claystone, mudstone and shale  
associated with other rock types. Rock weathers  
rapidly on exposure forming clayey soil highly  
susceptible to sliding. Includes covers (U-shaped,  
shallow valleys) containing thick layers of clayey  
soil that are very susceptible to sliding where  
excavation breaks continuity of slope and where  
overloaded by artificial fill.

**AREAS LEAST PRONE TO LANDSLIDES**  
Map areas in which no patterns or symbols are shown;  
primarily valley floors, ridge tops and broad  
benches; modification by excavation and fill may  
lead to local landslides.  
Includes slopes where landslides are sparse.
